A/E #1 ALTERNATOR SHAFT RECONDITIONING

SERVICE REPORT

680kW NISHISHIBA ELECTRIC AC ALTERNATOR

CLIENT : VALLES STEAMSHIP (CANADA) LTD
VESSEL : SEAHERITAGE
DATE : 09 NOVEMBER 2017
S/N : 619074A1A-1
JOB NO. : PJ0084-17-002

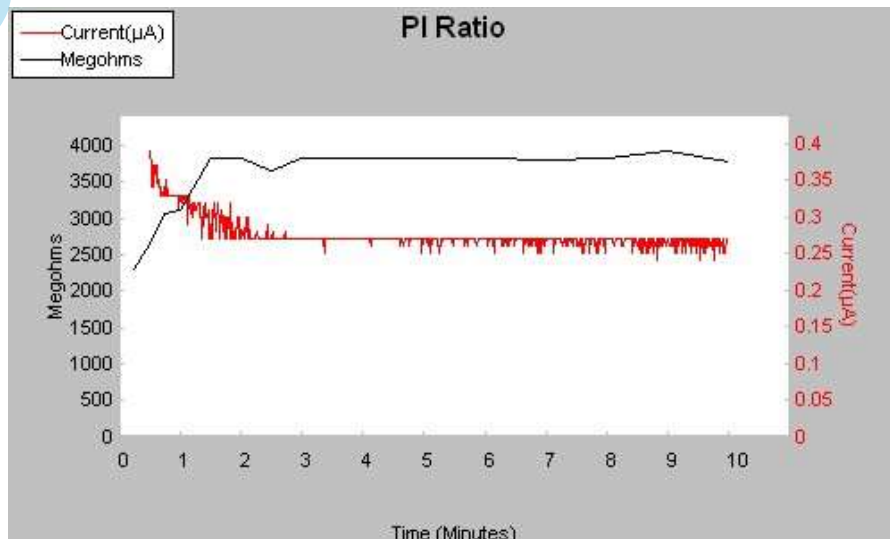
Continuation.... Polarization Index Test of the Main Stator Winding

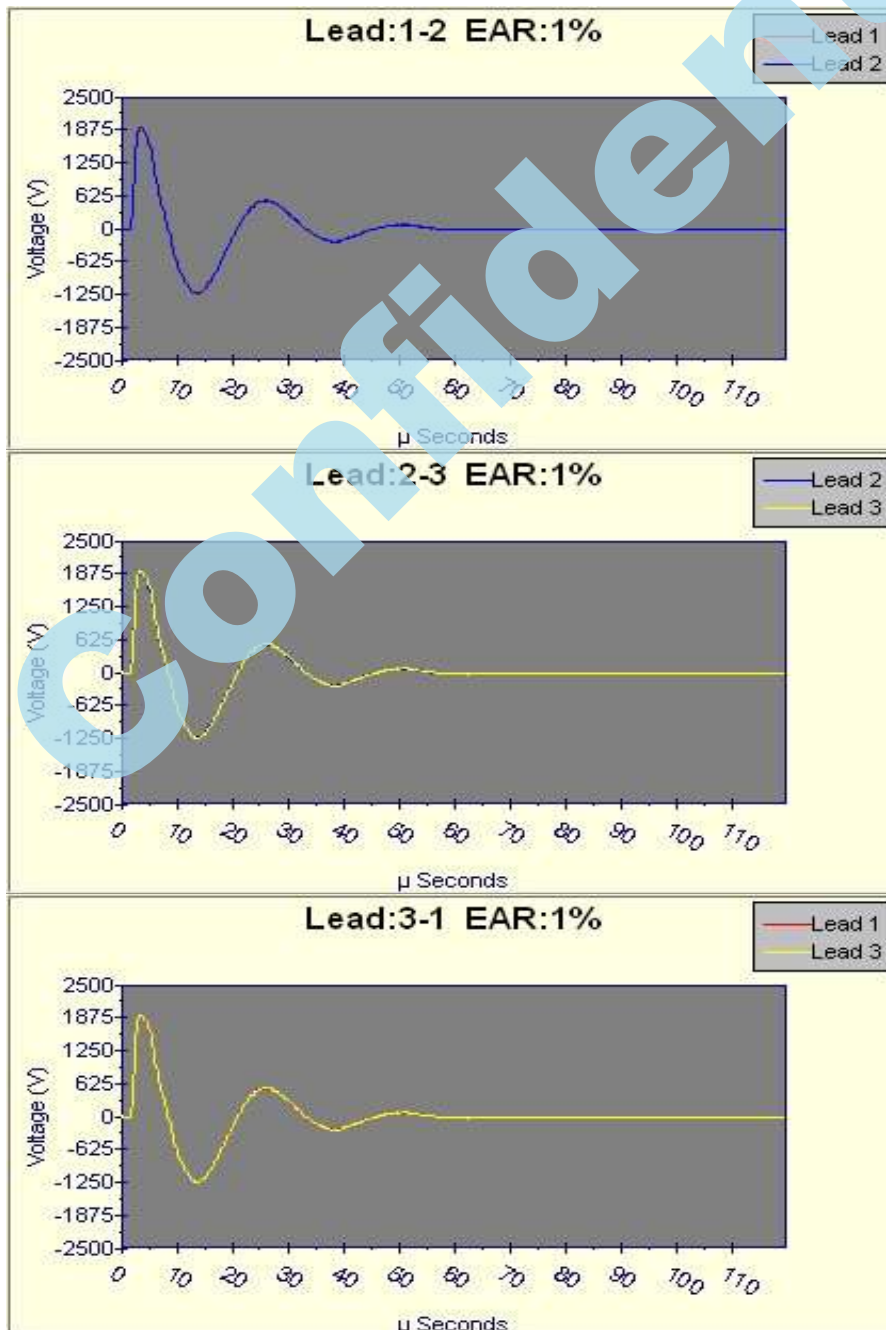
Continuation.... Surge Test of the Main Stator Winding

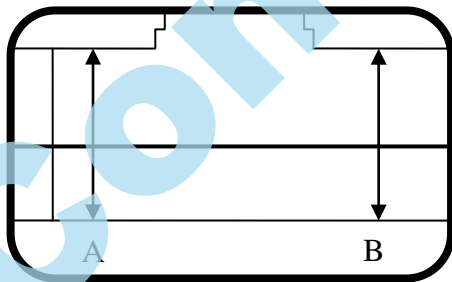
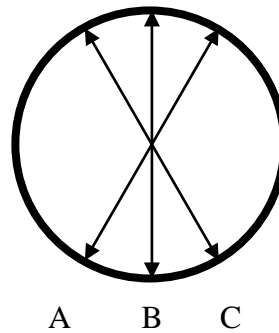
Diameter Point of Measurement

Bearing Bore Diameter

| Bearing Bore Diameter | | | | | |
|---|---|---|---|---|---|
| Bore Dia. @ 1 (Outer side) Facing shaft end | Top/Bottom | 130.25mm | 130.23mm | 130.26mm | |
| Bore Dia @2 (Inner side) Facing Rotor winding | Top/Bottom | 130.26mm | 130.25mm | 130.25mm | |

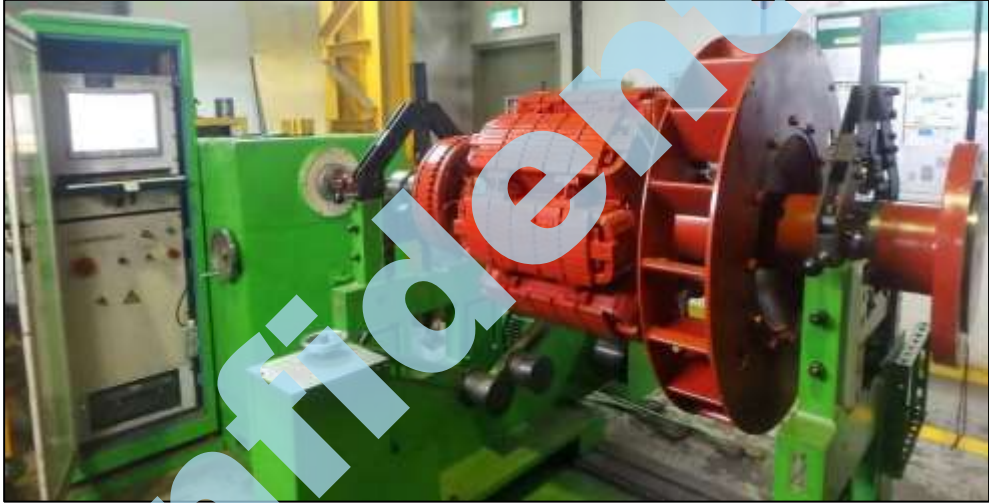
| DYNAMIC BALANCING REPORT | | | | | | |
|---|---|---|---|---|---|---|
| Description | Main Rotor with complete assembly | | | | | |
| Rotor Weight | 1500 kg | | | | Operating Speed | 900 rpm |
| Rotor parameters | A | 200 mm | B | 1150 mm | C | 160 mm |

Remarks: Balancing OK

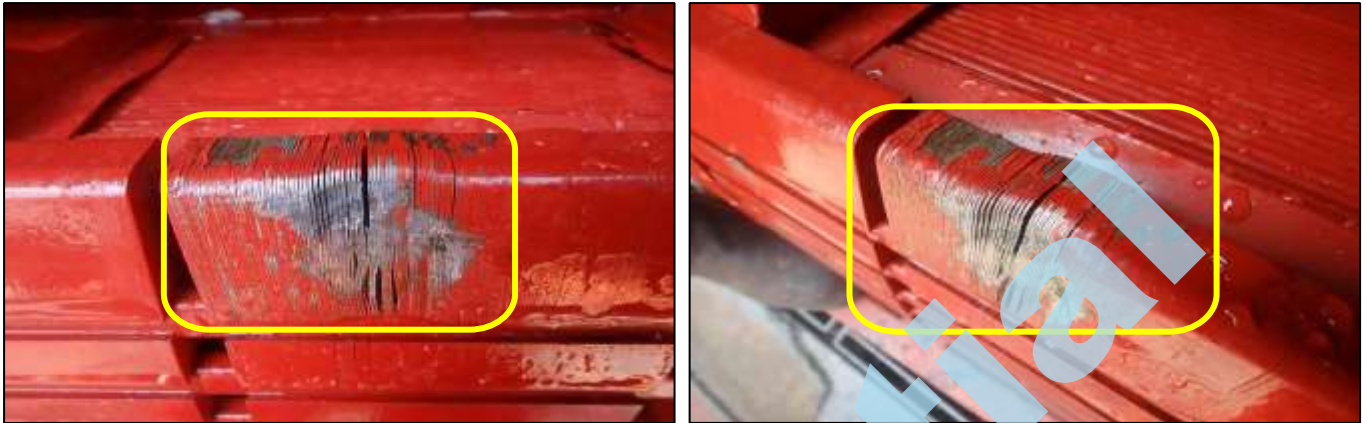
- Found with dent mark on the lamination core of rotor field winding. (See Figs: 4 & 5)

Fig 4 & 5: Condition of main rotor after dismantling, was found dent mark as shown in photo.

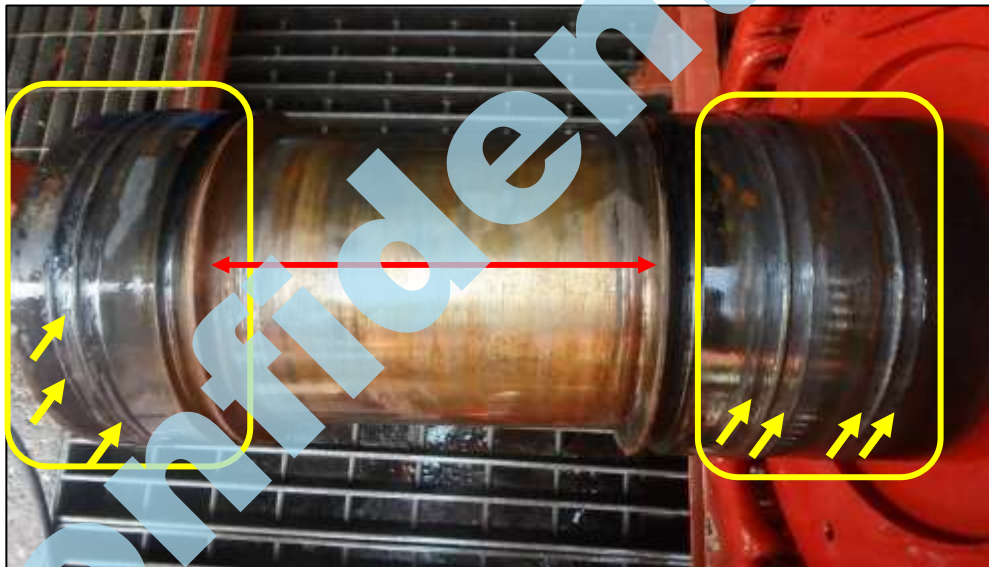
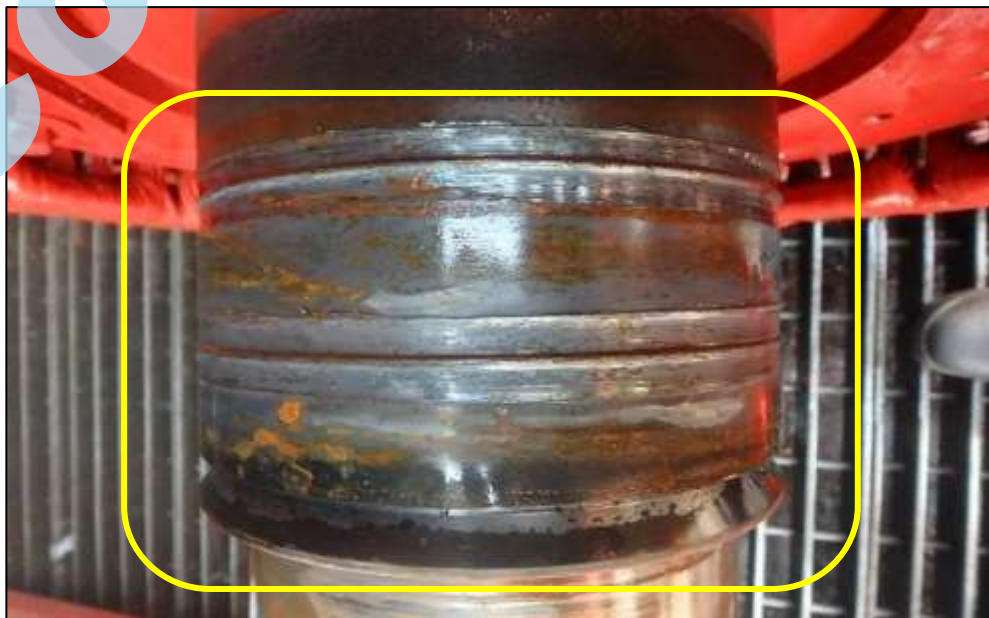
- NDE journal of rotor shaft was found worn-out with deep score marks at labyrinth journal

side (inner and outer). (See Figs: 6 & 7)

- NDE bearing journal of rotor shaft was found worn-out. (See Figs: 6)

Fig 6 & 7: Condition of rotor shaft journal after dismantling, was found deep score marks.
(Shaft journal was repaired by CRC)

Recommended to carry out repair by pre-machining, MPI Test, pre-heat treatment, rebuilt, machine to size and final MPI Test. (Repaired done by CRC)

Recommended to carry out polishing. (Done by CRC)

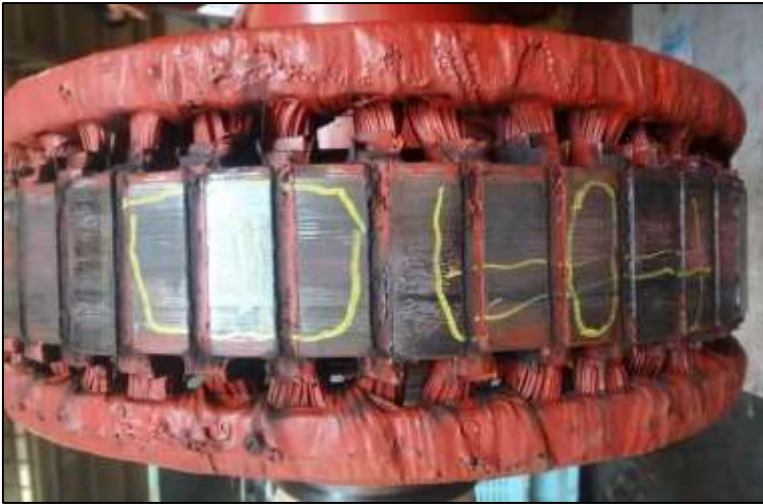
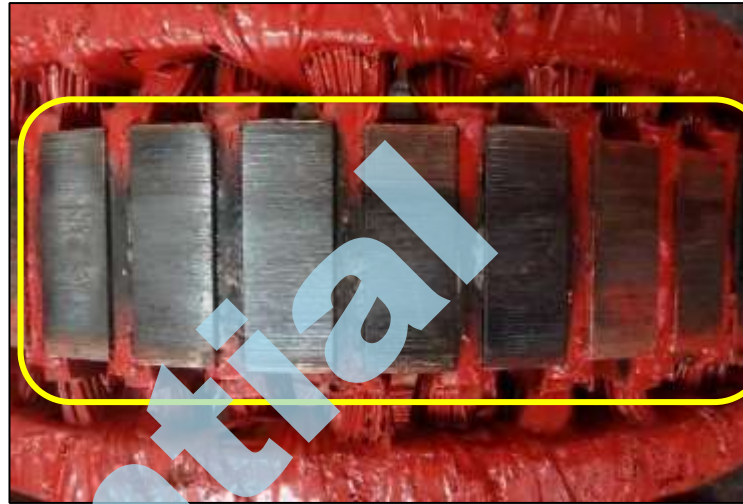
rotor. Insulation resistance was found (5.2 MΩ) as received.

Fig. 8 & 9: Condition of exciter rotor was found with rubbing marks as received.

Recommended to carry out rewinding on Exciter Rotor winding due to the rubbing marks found on the lamination core which burnt the slot insulations.

(See Figs: 8 & 9)

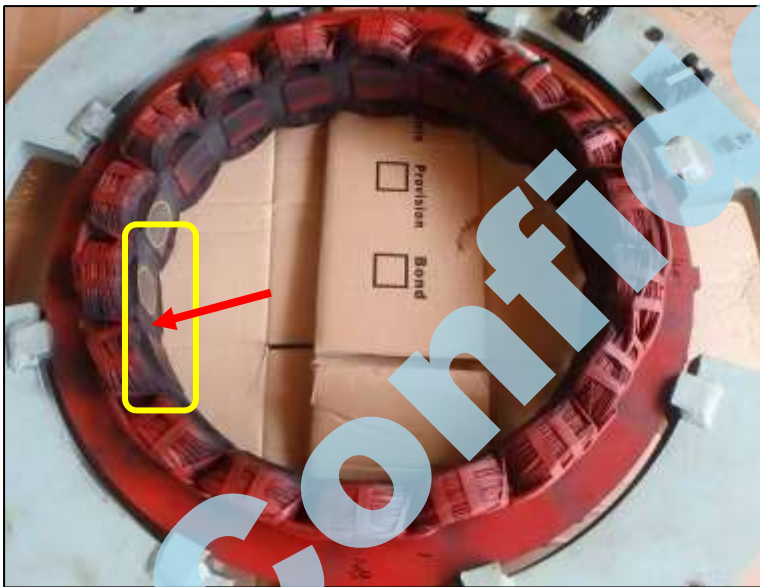
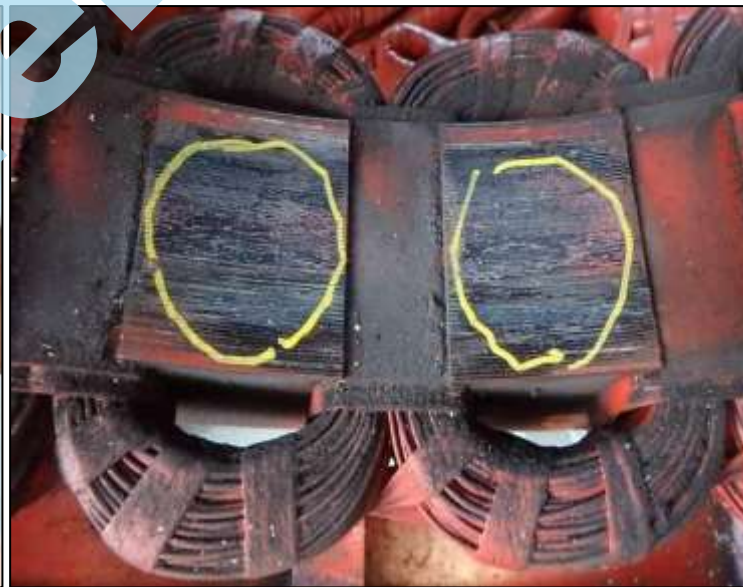
- Found with some rubbing marks on the lamination core of exciter field winding.

(See Figs: 10 & 11)

Fig 10 & 11: Exciter stator was found with some rubbing marks as received.

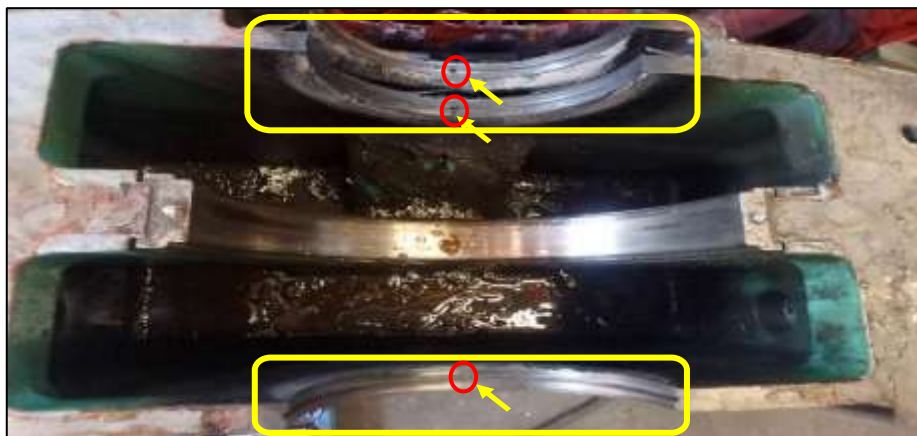
Fig. 12: Condition of lower part bearing housing as received.

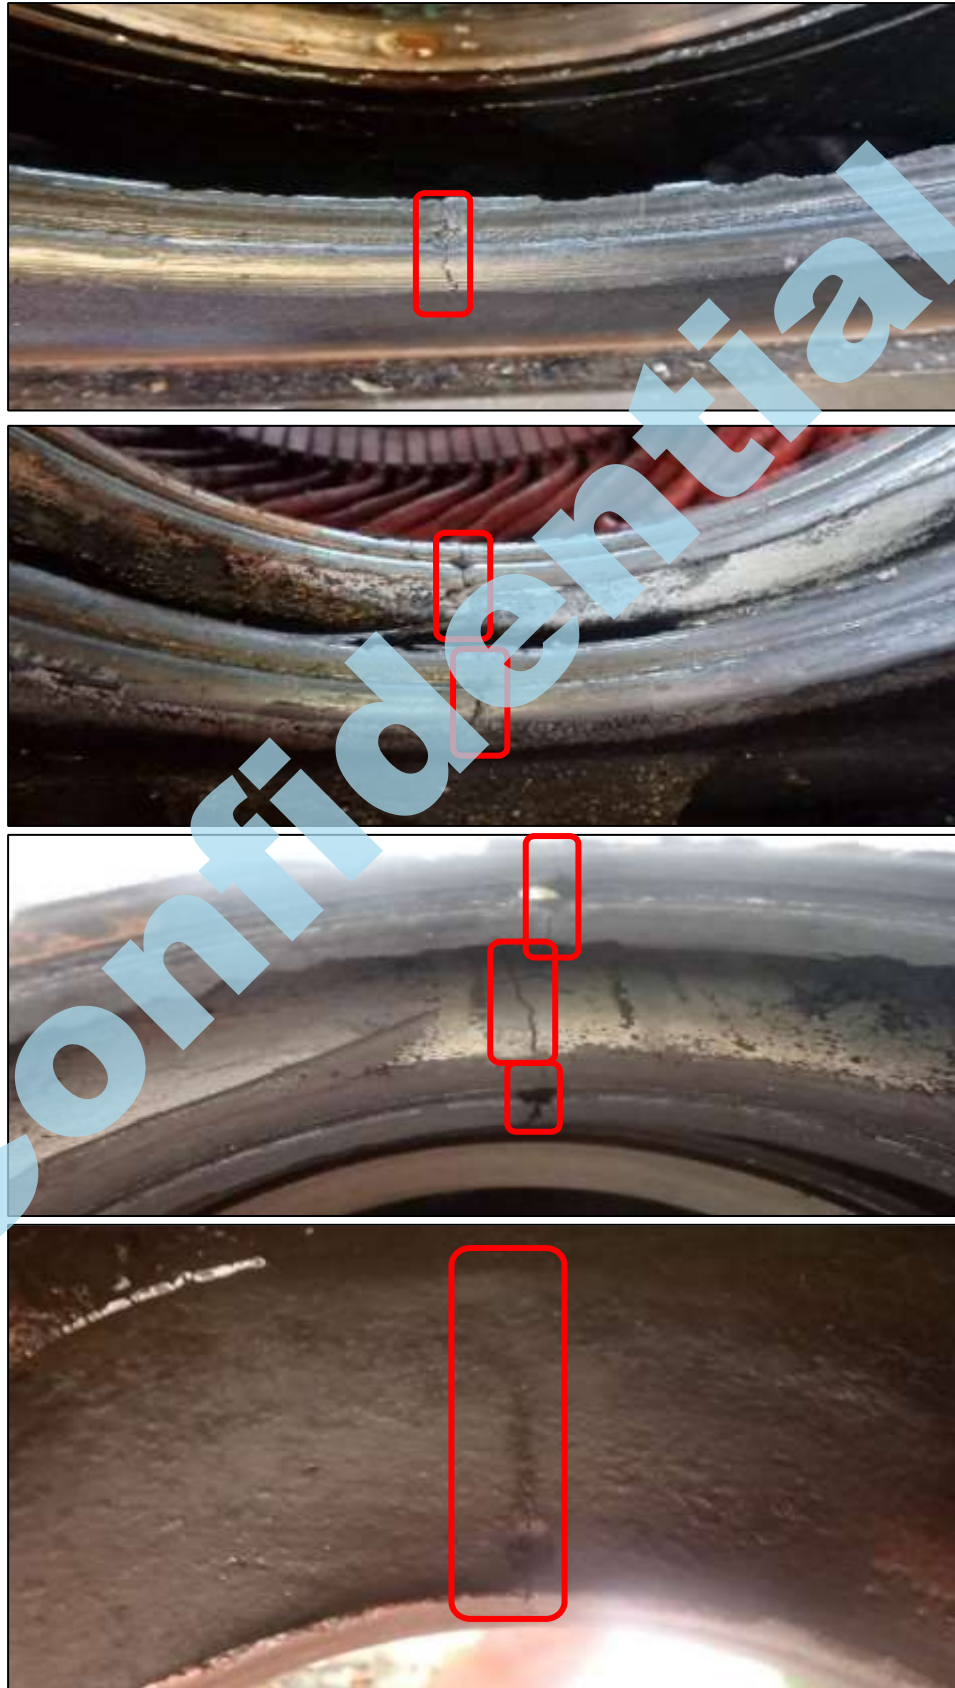
- Lower part of bearing housing was found badly melted with crack lines on the collar.

(See Figs: 13 to 16)

Fig 13, 14 & 15 & 16: Lower part bearing housing was found badly melted collar with internal deep long crack lines.

Recommended to carry out repair. (Repaired done by CRC)

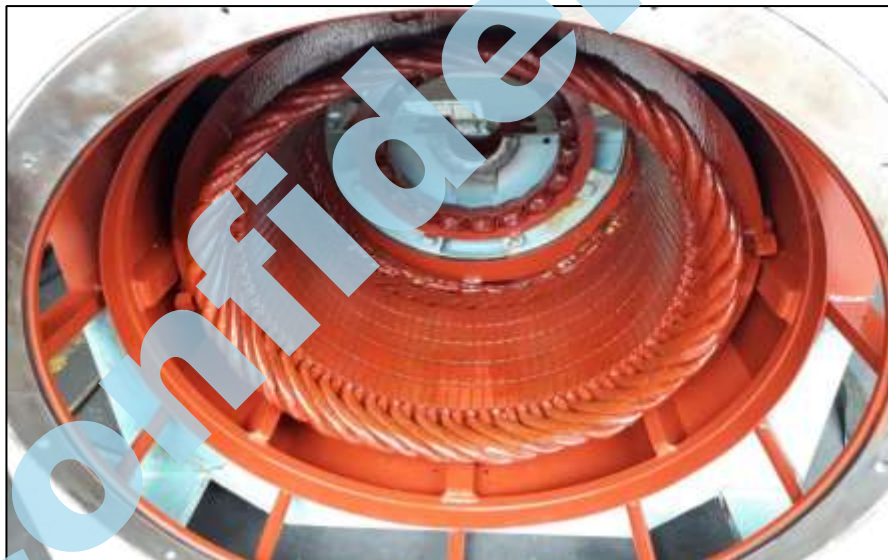
Fig. 17 & 18: Condition of Main Stator after servicing.

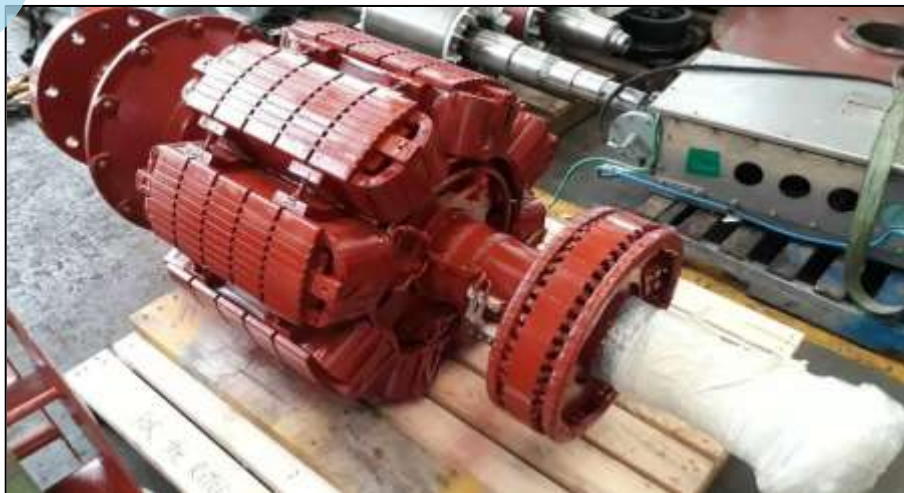
Fig. 19: Condition of Main Rotor after servicing.

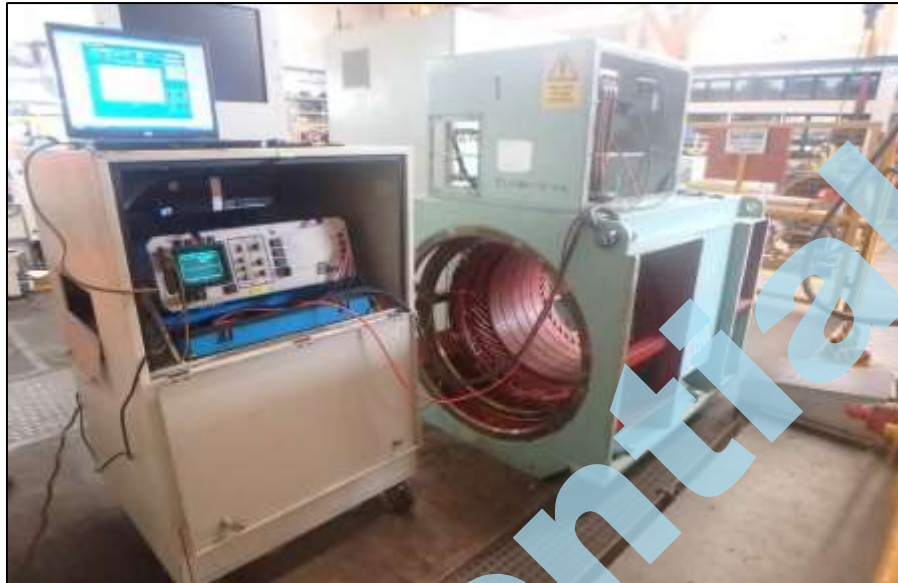
Fig. 20: Condition of Main Stator insulation test, hi-pot and surge testing in progress before reassemble.

- Carried out winding resistance, insulation resistance, hi-pot & surge test, after steam and chemical washed; found that main stator winding testing result was satisfactory. Insulation resistance was found (87 MΩ) as received the alternator.

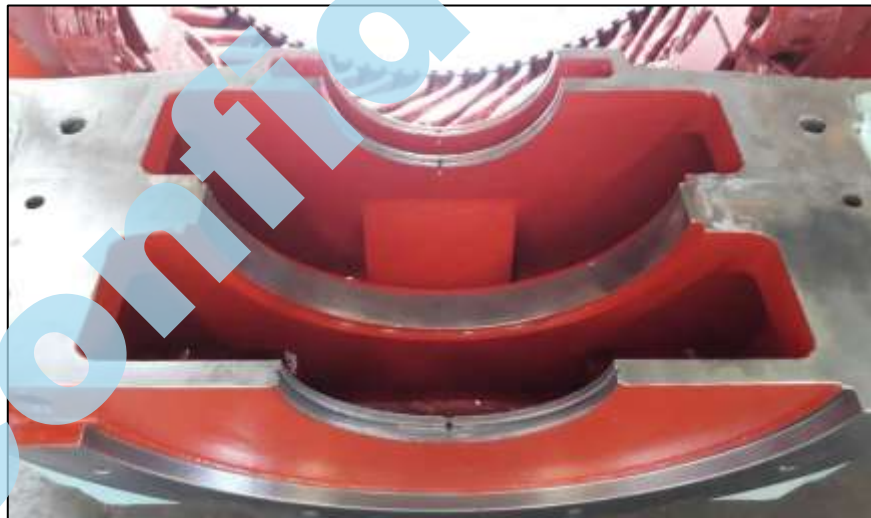
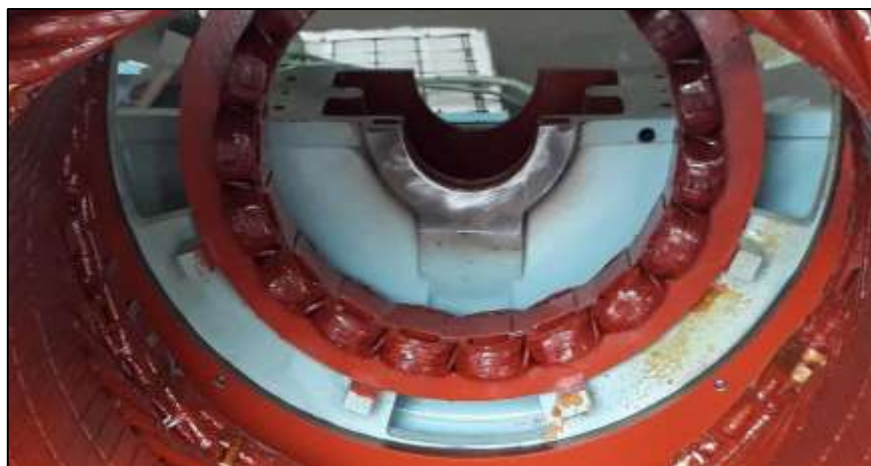
Fig. 21 & 22: Condition of Lower part bearing housing after re-installed.

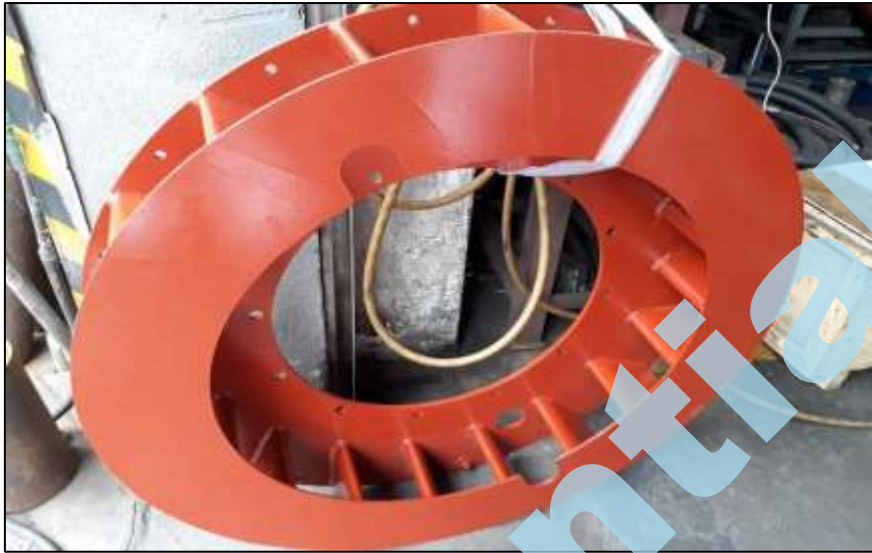
Fig. 23: Condition of impeller before installed and after servicing.

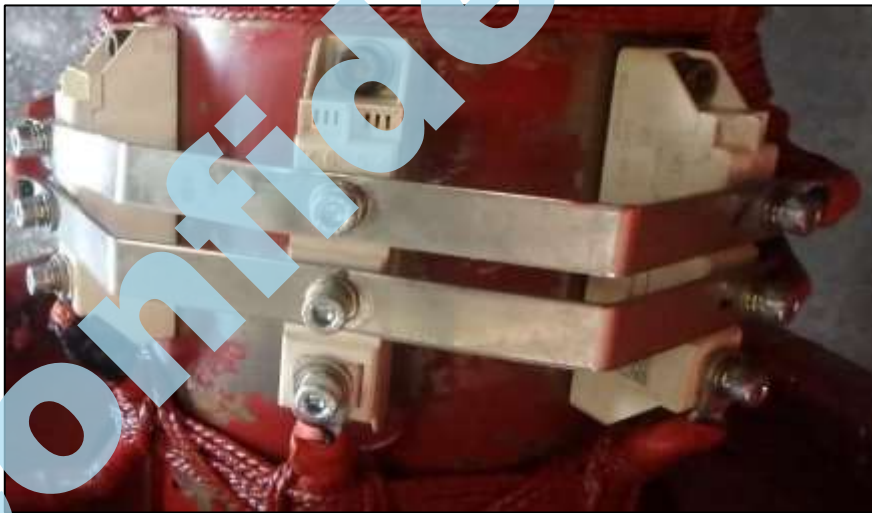
- Supplied and installed 3 nos. of Bridge Diode and install on rotor shaft as rectifier.

Fig. 24: Condition of Rectifier bridge diodes after renewed and installed as per original.

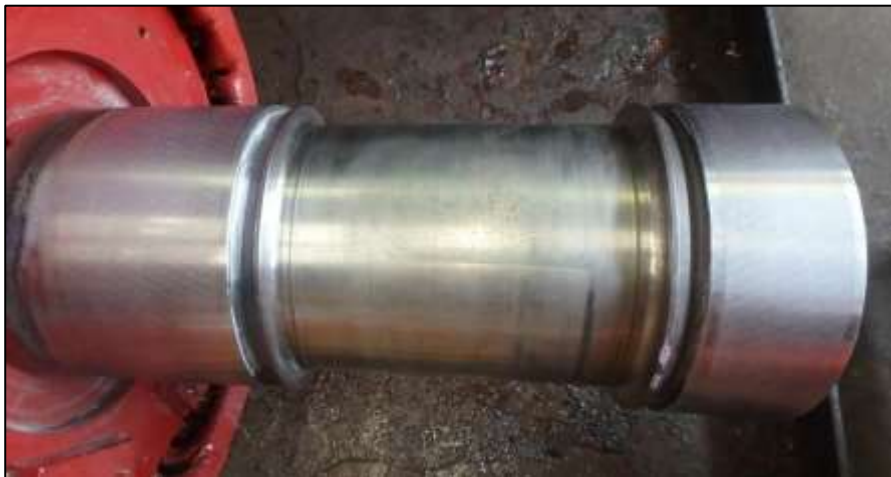
Fig. 25: Condition of rotor shaft journal after repaired by CRC.

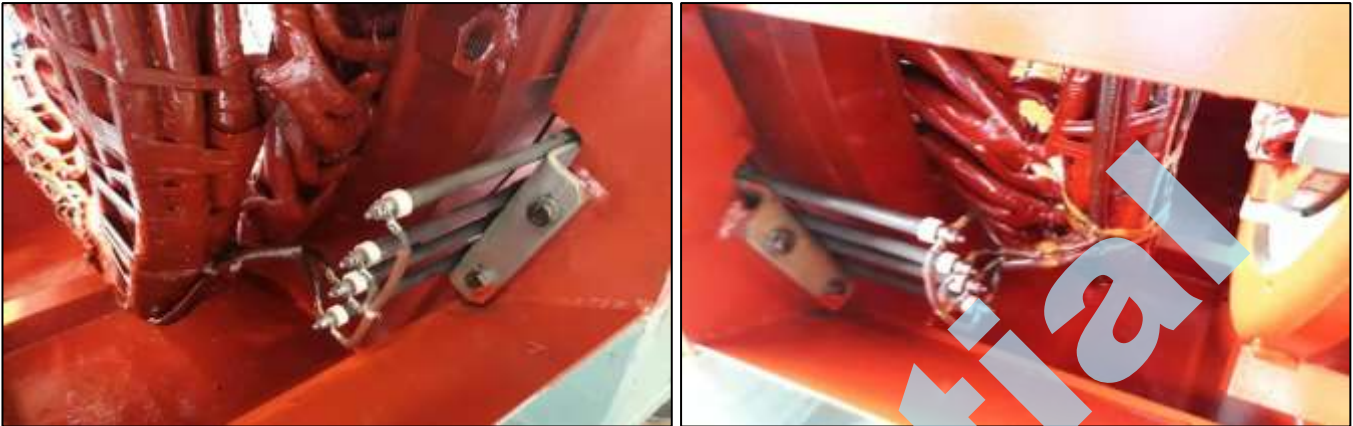
Fig. 26 & 27: Condition of LH space heater and RH space heater after re-installed as per original.

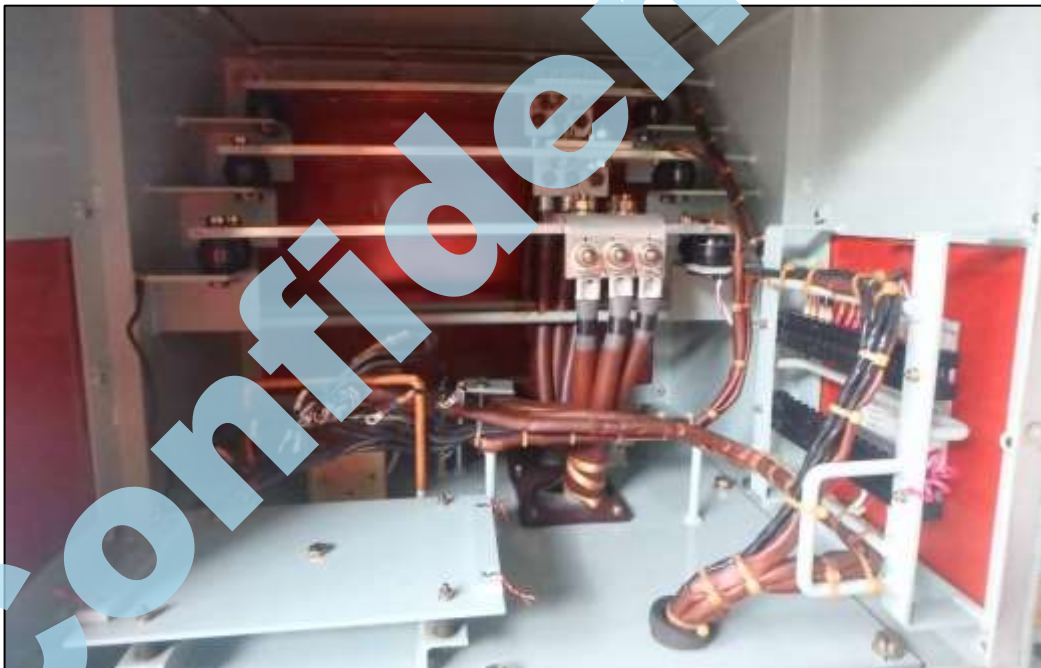
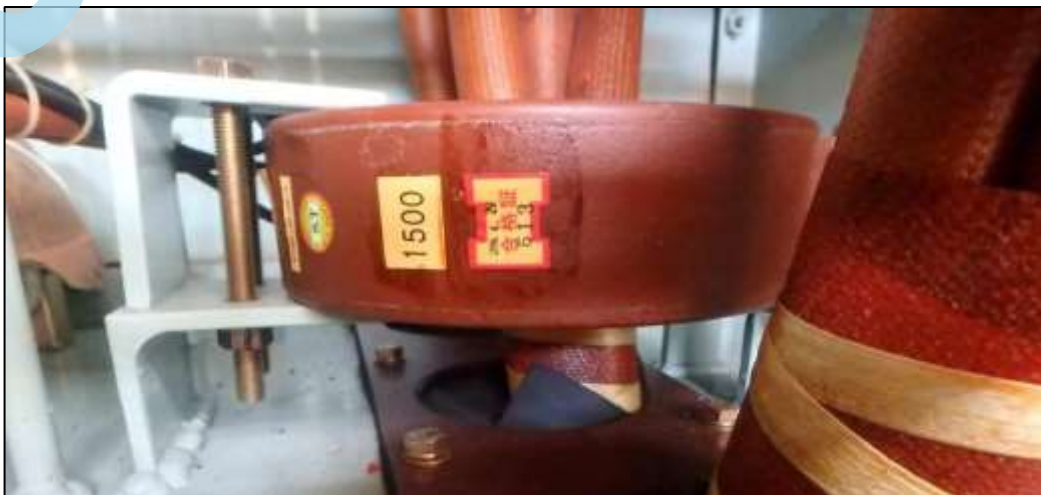
Fig. 28 & 29: Outgoing power supply terminals, some control terminals, CT & resistor after re-installed as per original.

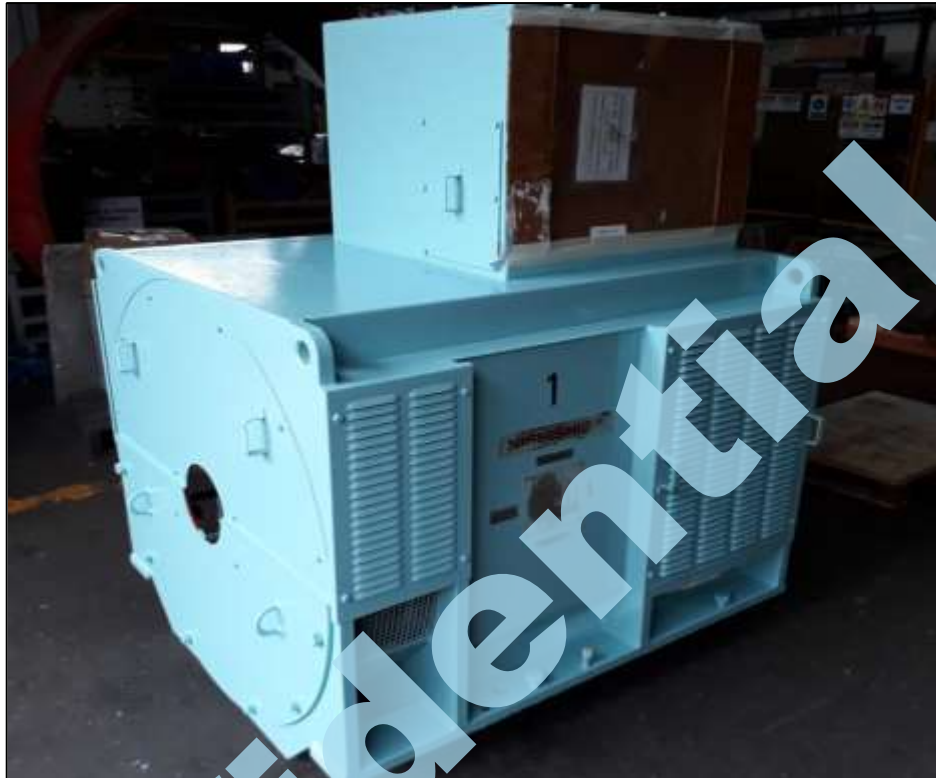
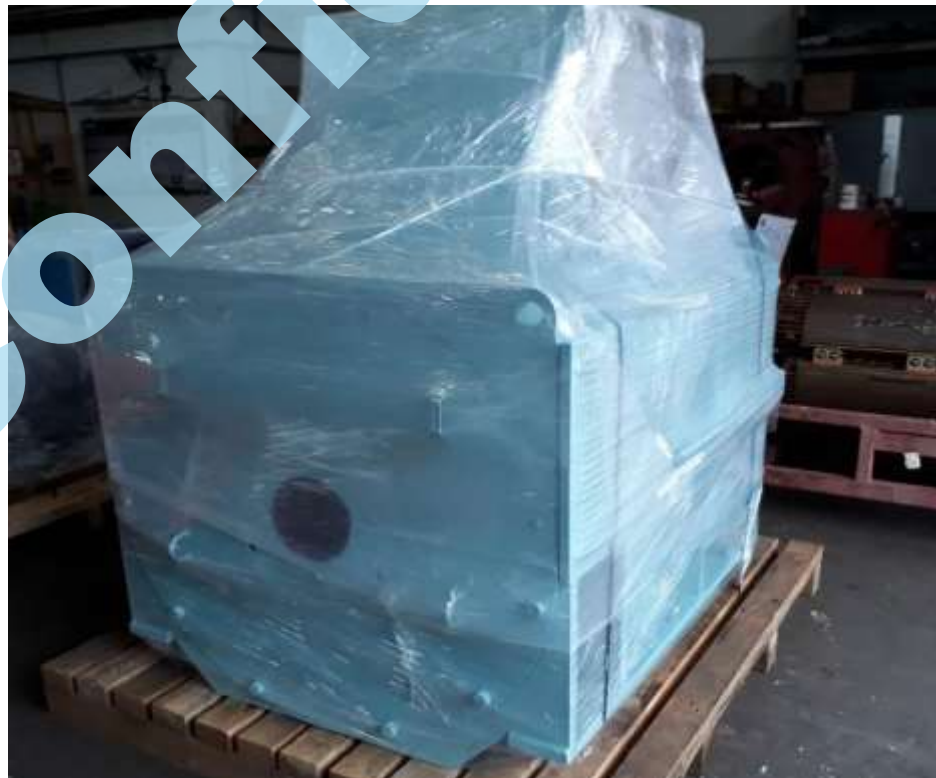
Fig. 30 & 31: NISHISHIBA Electric Alternator after servicing and ready to dispatch.
